MEMORANDUM REPORT ARBRL-MR-03338

BLAST LOADING OF CLOSURES FOR USE  
ON SHELTERS-II

George A. Coulter

February 1984

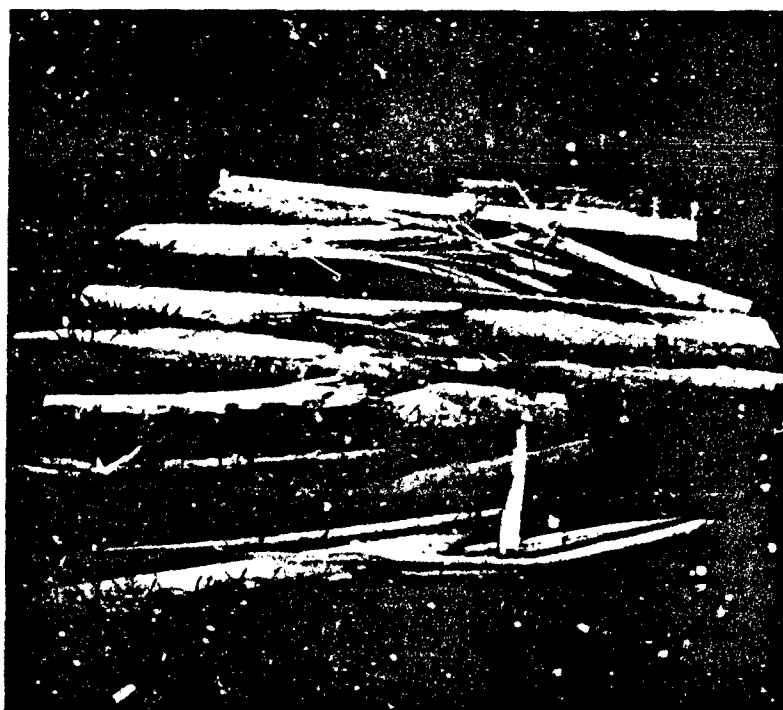
Figure 15. Oak Plank/Sand Bag - 344 kPa (49.9 psi).

Figure 15 shows the results of the oak plank/sand bag closure. As noted from the high speed photographs, failure did not occur until after perhaps 50 ms. This closure was just on the borderline of being satisfactory. One beam did remain in the test fixture but all sand bags were blown out. Figure 15-C shows the shredded state of the sand bags collected after the shot.

As noted previously in the results section, only one shot was fired with the sand bags in place. The closure did fail but only after a relatively long time. The curve for "closure - with sand bags" can at best be considered marginal at the test level of 345 kPa.
